IDENTIFYING LEAKS IN PLASTIC ANTIFREEZE CONTAINERS

Tested: Plastic Antifreeze Bottles

Tested with: TapTone 1000-C Compression System

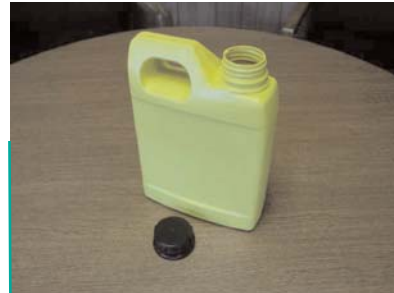
Plastic antifreeze bottle

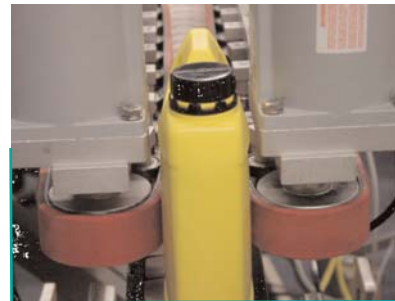
Bottle being tested with the T1000-C

The T1000-C Compression Sensor utilizes dual parallel belts to apply force to the sidewall of a passing container. This action also compresses the headspace of the container which allows a load cell to take a force measurement at the discharge of the system. Utilizing DSP technology, the controller analyzes the measurement and assigns a merit value to each container. If the merit value is outside of the acceptable range, a reject signal activates a remote reject system.

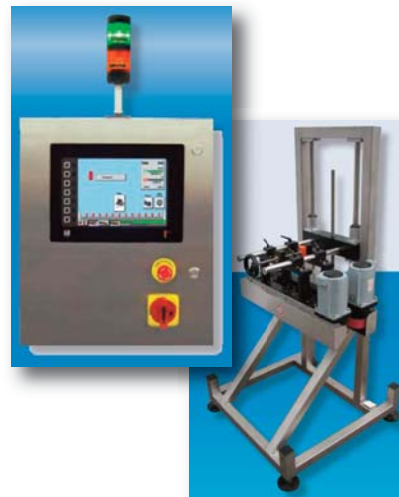
T-1000 Compression Controller and Sensor. Sensor has a cantilever design that suspends over the existing conveyor.

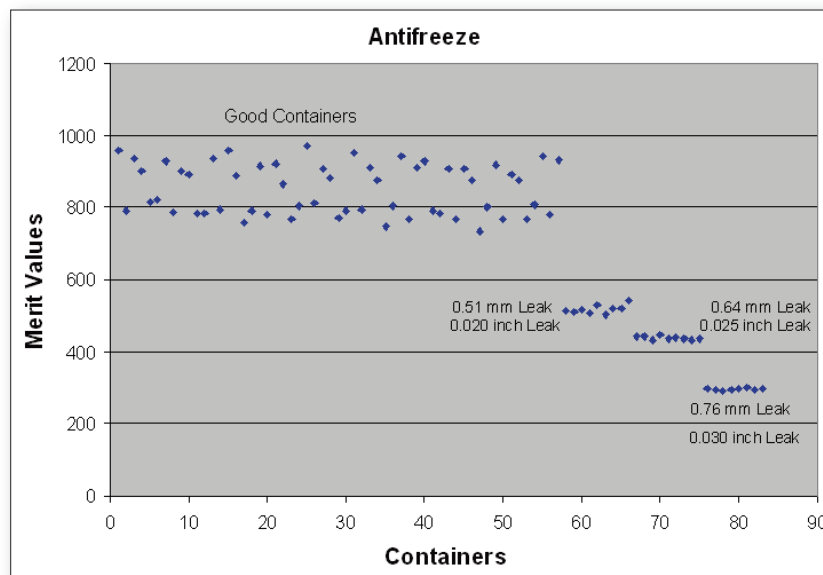
During the compression cycle, the sealed, non-leaking containers generated an average merit value* of 875. When leaking containers were introduced, those with hole sizes of 0.51 mm, 0.64 mm and 0.76 mm (0.020, 0.025 and 0.030 inches) produced average merit values of 500, 425, and 300 respectively.

*Merit value is a calculated number determined using an algorithm to compute a resultant from a set of data values.

Testing was successful with the T1000-C. In the samples provided, the system was capable of consistently detecting leaks with a diameter as small as 0.51mm (0.020 inch).
